Stephen H Shakeshaft Consulting Ltd
75 Mere Bank, Davenham, Northwich, Cheshire, CW9 8NB.
Tel- 01606 331558 Mobile- 07779 190087 Email- steve@shs-consulting.co.uk

Acid contamination of Lubricant causes breaking Piston Rods on a Reciprocating Compressor.

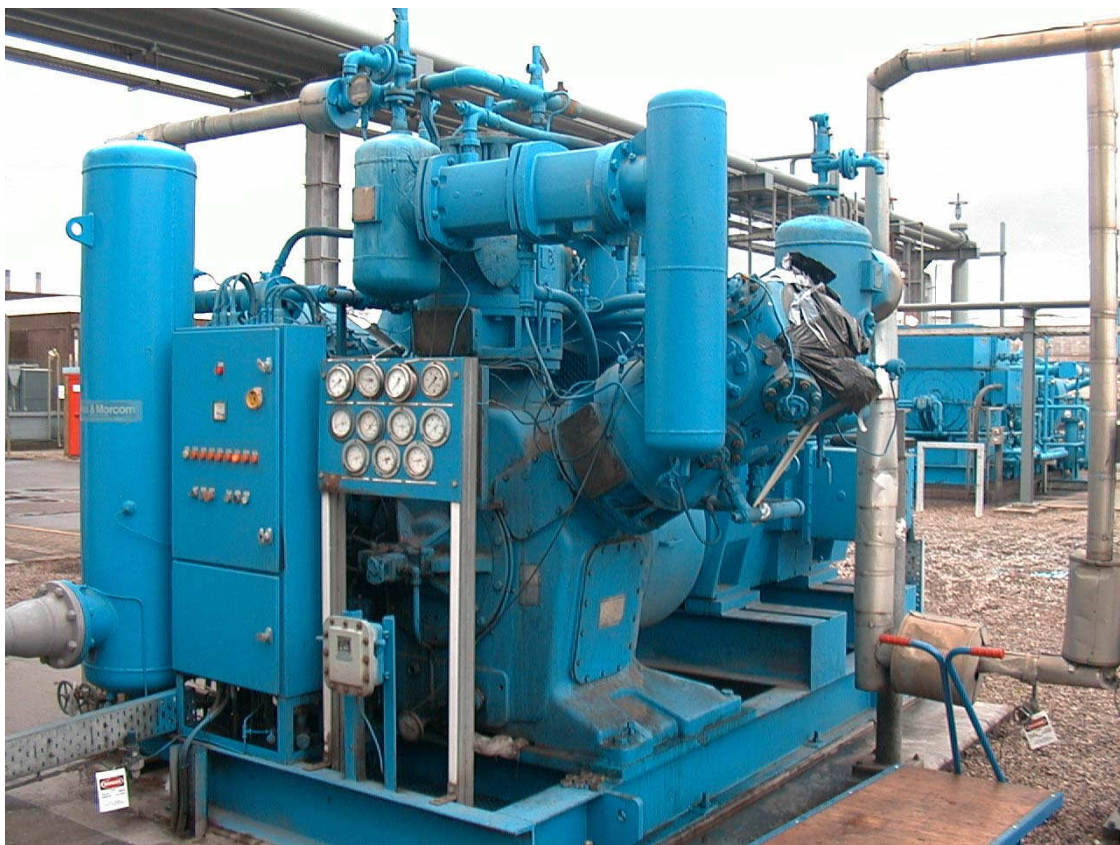
The double acting compressor cylinders were in a “W” arrangement with the outer cylinders of the “W” being both first stage cylinders and the centre one being a second stage cylinder. (See below).

Compressor with “W” cylinder formation.

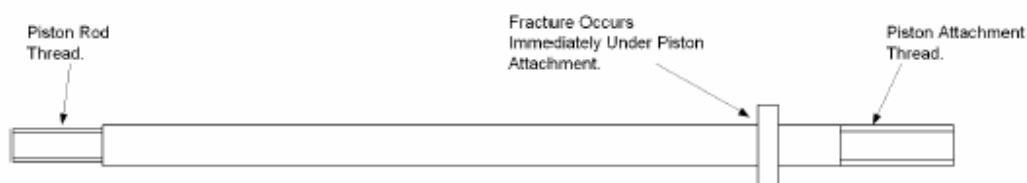
I was advised by the service person and by a plant operator that the machines were regularly taken out of service due to carbon build up inside the machines cylinders and the valves of the machines. Sometimes, the end clearances inside the cylinders became so reduced that the pistons would touch the cylinder head and the piston rod would snap underneath the piston attachment. Usually, the contact took place on the downward stroke with the underside of the piston striking the head at bottom dead centre. See Fig 1.

Somewhat surprisingly, when this happened the failed piston rod would push the piston back up the cylinder on the next stroke and the machine would keep running. The only clue to a piston rod breaking was pressure dropping off in the plant as the flow from the machine reduced. Although I was really rather concerned about this, the plant operator and the service person were not in the least perturbed as they saw this happen fairly regularly. They just took it as a sign that the maintenance of the machine was due.

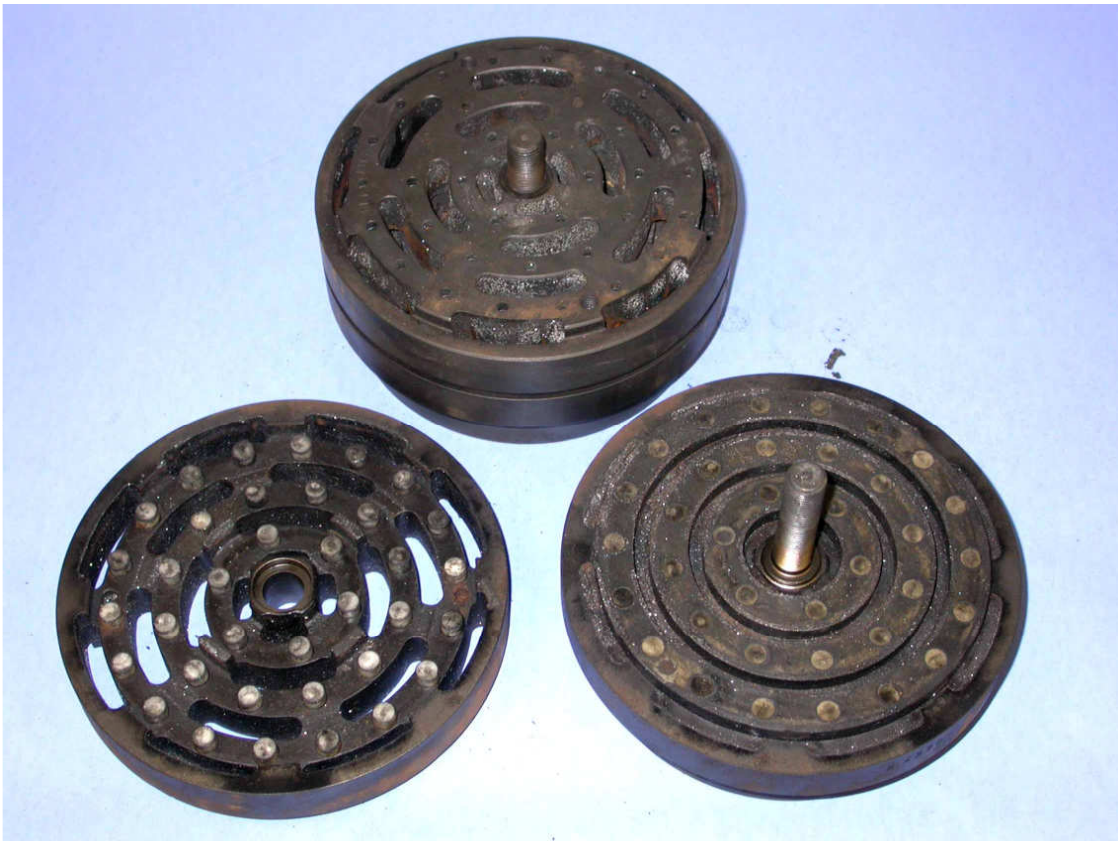
Inspection of all parts of a dismantled machine showed the very heavy carbonisation that had been a characteristic of these machines for all those years. All internal surfaces in the cylinders were extremely heavily fouled with oily, black, hard carbon deposits. The gas passages of the inlet and outlet valves were heavily choked. See below.

Carbonised Compressor Valve.

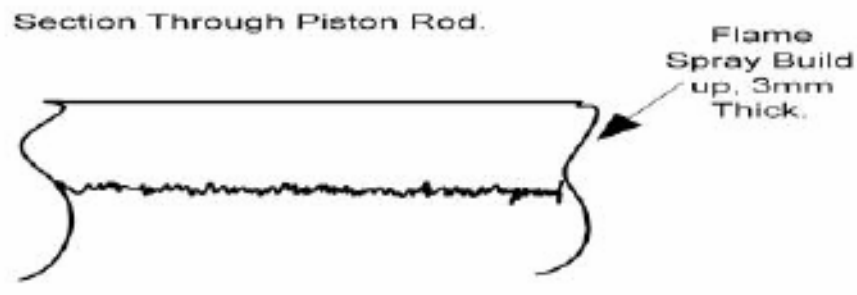
Fig 2.

The rod had fractured immediately below its piston attachment. What was readily apparent was a change in material characteristic about 3mm deep all round the periphery of the rod.

that the apparent discolouration seen at the jobsite was in fact a very thick layer of Metallic Flame Sprayed build up. At first this seemed bizarre, but upon talking to the plant supervisor it became clear that they didn't put new piston rods in the machines because they didn't last very long. They sent them to a local workshop who metal sprayed them back to the original diameter and sent them back to the stores.

I went to talk to the local repair workshop who were preparing and flame spraying the rods. It soon became apparent that the repair workshop didn't know what the piston rods were or what they did. To them they were a worn piece of round bar with a thread at each end. They just prepared them with a coarse machined finish (perfect conditions for stress propagation to occur) and sprayed them and then turned them to a given diameter to finish off. The reclaimed rods were then put back into stores as supposedly fully refurbished items. It was notable that neither the plant nor the reclamation workshop understood what was required in refurbishing a piston rod or what the parameters might be to scrap the rod. The manufacturers representative gave no advice on the condition or refurbishing of the rods, he just used the parts he was given free issue by the client. In fact, the rod that was broken had a flame sprayed coating that was 3mm thick on a rod that was only 47mm diameter. So the effective diameter was reduced to about 41mm. See Fig2.

The workshop didn't think there was any limit to how thick the metal spray coating could be as long as the final diameter was as specified.

Over the following months, the relevant staff were re-educated about the importance of proper refurbishment procedures and a full procedure for piston rod refurbishing was written and put in place.
