Fatigue Failure of Compressor Bolting.

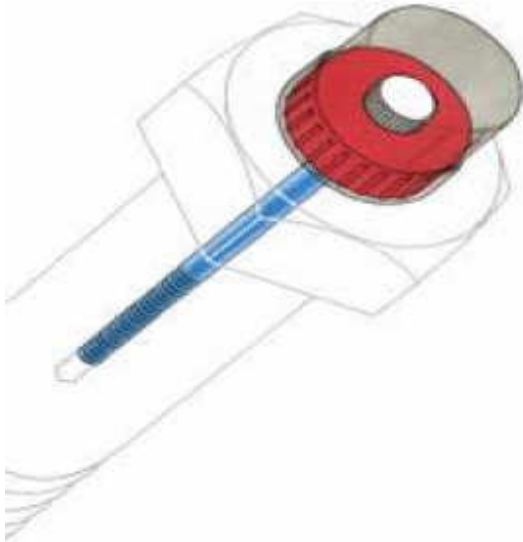
Method 2- Load Controlling Fastener. Using this technique, again each bolt is calibrated in the laboratory. However, each bolt is fitted with a gauge pin under the head of which is a washer free to spin. The air gap under the head of the gauge pin is set such that at the desired tension, the bolt is stretched sufficiently to close the air gap and the washer becomes trapped.

Each fastener is calibrated to be within +/-5% of the desired bolt tension.

The big advantage of the Load Controlling Fastener is that once it is set up, the bolt can be instantly monitored for tension without use of any tools and while the machine is operating.

Above- Load Controlled Fastener.

This fact was enough to make the decision to use Load Controlling Fasteners on these machines.

Two complete sets of Load Controlling Fasteners were ordered up, one for each cylinder assembly.
