Recurring Failure of Sodium Shear Pump due to Seal Lubrication Problems.

The front end of a batch process plant consists of a Sodium Dispersion section.

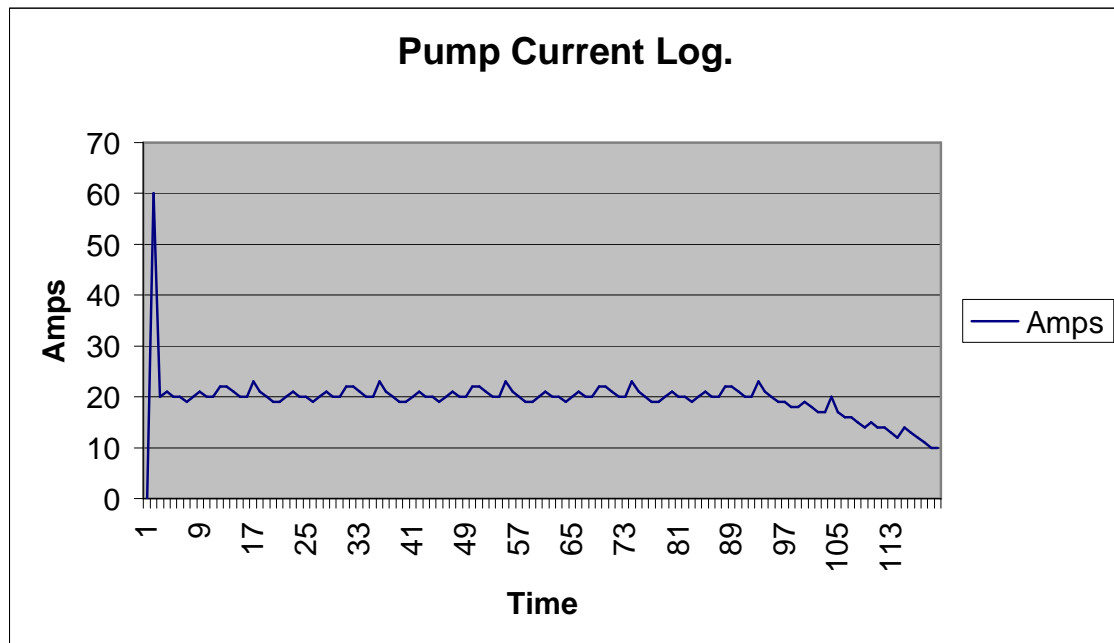
It was immediately apparent that the pump was losing its suction. There were clear signs from the data gathered by the ammeter/data logger combination that after a period of time the amps would fall off.

This could only mean that the pump was doing less work, i.e. pumping less. Therefore, logically, something was restricting the flow into the pump.

The Excel spreadsheet charts below show actual data collected from the pump's motor.

The amps are seen to settle down after the initial start but then drop to around 50% of the "normal" value. This clearly illustrates a fall off in pump load and that the suction of the pump is blocking.

Above, chart showing falling current, suction blocking.

1. The tank was opened and cleaned. A large amount of finely divided metallic sodium was clinging to the sides of the tank and to the instrument probes in lumps. A lump the size of a small rugby ball was clinging to the temperature probe just waiting to fall off and block the pump.
2. The specification of the sodium has been changed from one that contains small quantities of calcium to pure sodium. The price difference is negligible. The calcium level was building up over time in the tank and causing the agglomeration of the finely divided sodium into lumps with the consistency of soft wax. This was what was causing the pump suction to block.

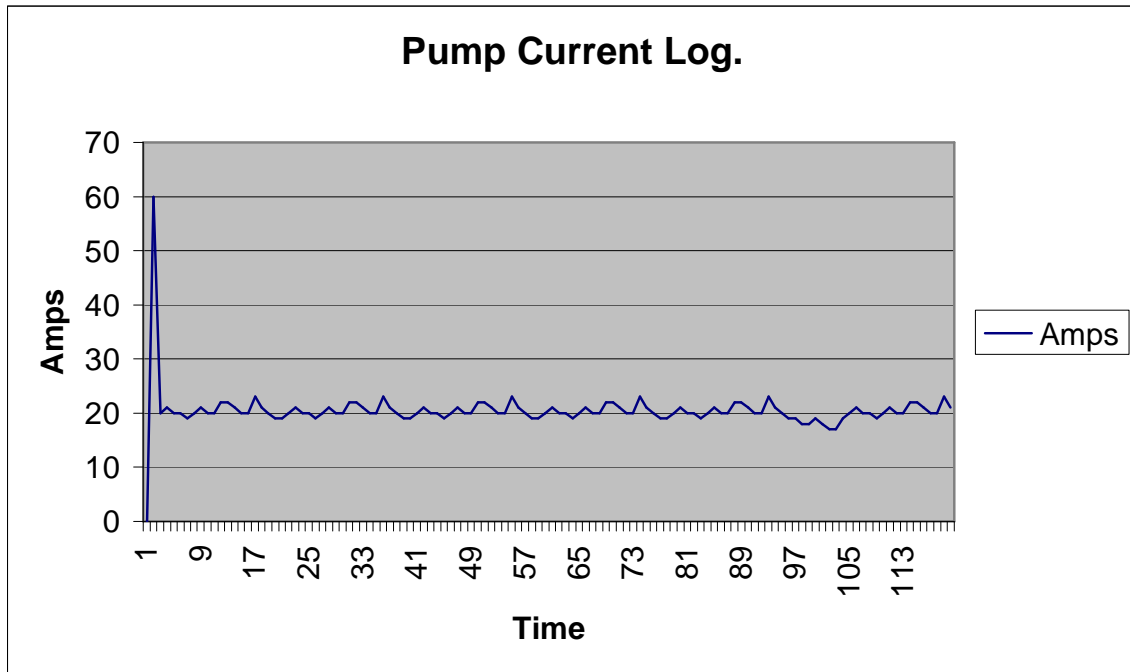
Above, chart showing steady current, no blocking.

In the second spreadsheet chart, the data is taken two months later when we had made changes to the way the pump operates.

It can clearly be seen that there is a solid horizontal trace right across the spreadsheet.

The changes that have been made to the process operation are as follows-

3. The operators all operate the unit in the same way consistently and we can tell straight away from the ammeter traces if any deviation is occurring before it gets serious.
